## Of Brecks thatch and sparrows

Stephen Letch

### Summary

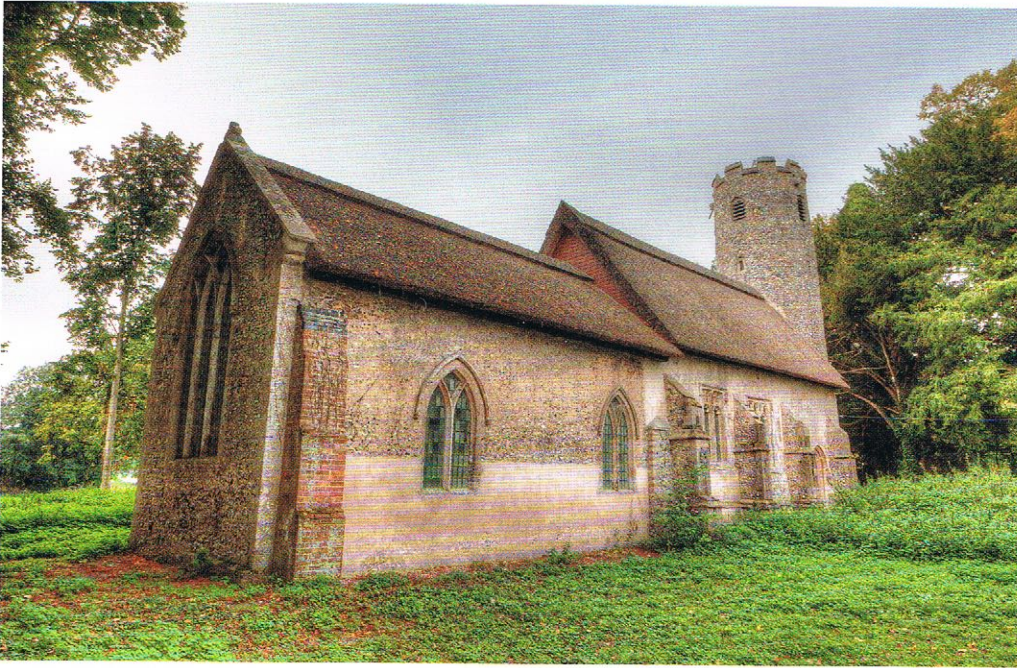
Figure 4.  
St Mary's Cranwich  
is one of several  
thatched churches  
in the Brecks. It has  
been thatched by the  
author.  
Image © Nick Ford.

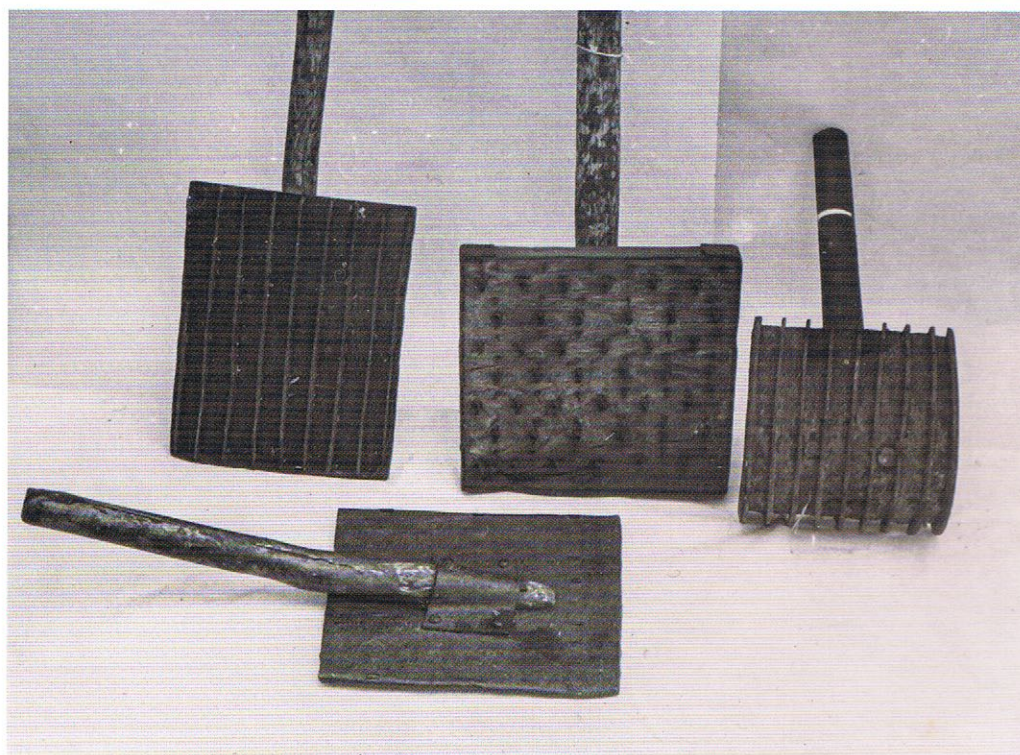
Figure 5.  
A variety of reed leggatts. From bottom, clockwise: topside steel plate showing how the wooden handle is fixed; underside of same finishing leggatt, showing welded steel bars to catch the butt ends of the reed and dress into position; general work-in-progress leggatt with horseshoe nails; curved finishing valley leggatt.

The first of the Reeve family for whom there are thatching records, Peter Reeve of Bridgham (dates unknown) was considered in the district to be a great craftsman and was usually preferred to some of those whom he described as ‘straw throwers’ and who put the thatch on rough and thin. Records from old thatching account books and estimates begin in 1860, and include accounts listing the costs of materials used on a thatching job as well as the costs of labour, enabling me to understand what techniques were being used by master thatchers between 1860–1968. (Fig. 5)

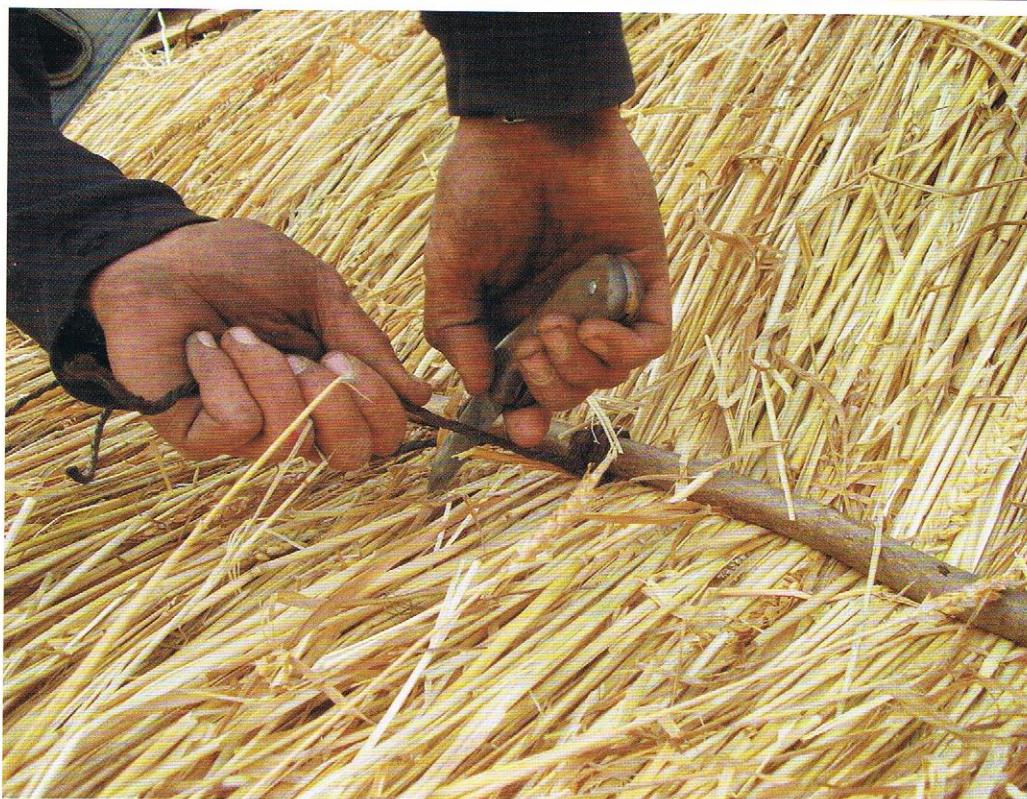
Figure 6.  
Finishing a tarred cord  
fixing around a rafter  
and hazel rod, using  
a clove hitch knot to  
secure the thatch onto  
a bare roof frame.

point at each end and twisted in the middle to make a staple called a brotch, used for securing the ridge (roofen) and for fixing a top coat of new thatch over old (Fig. 6).

The use of only two (iron) thatch-fixing hooks might be questioned as being insufficient, given that many more would be used by modern thatchers. However, in 1866 tarred cord (patented 1792) was used to bind the thatch onto the roof frame, using a needle threaded from inside the roof by a boy until only a small hole was left for access through which the two hooks were driven into the rafters when the thatch was finally covered over.

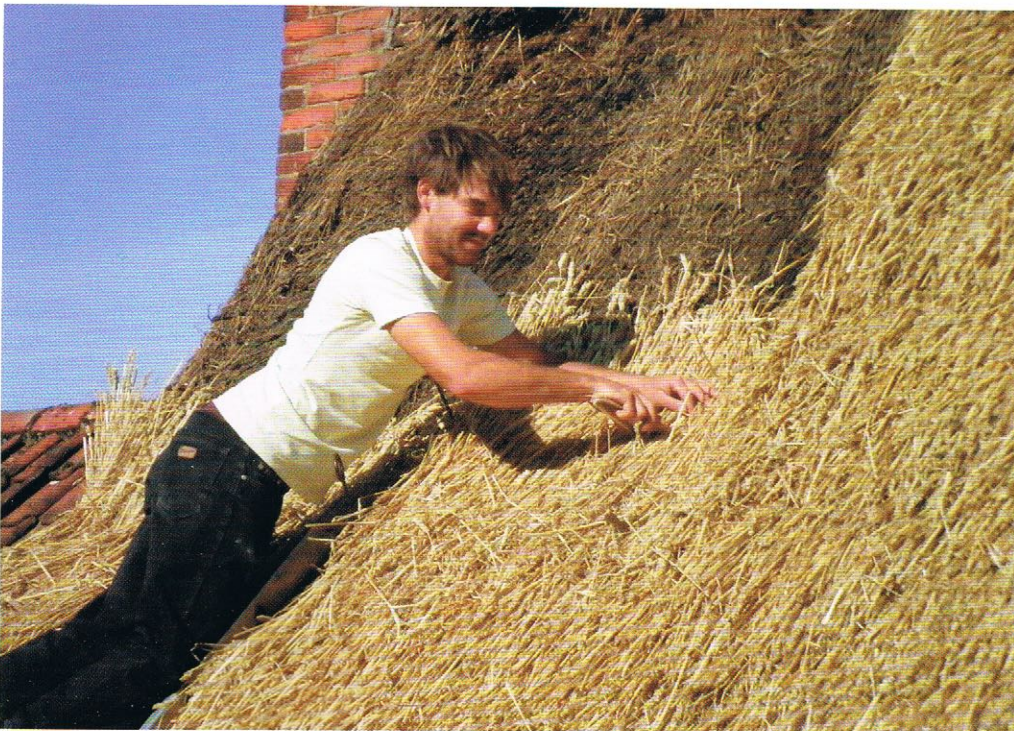
*Figure 7.*  
The author's former apprentice, Bodkin Willows, fixing new long straw thatch to an existing coat of thatch using hazel brotches (staples).

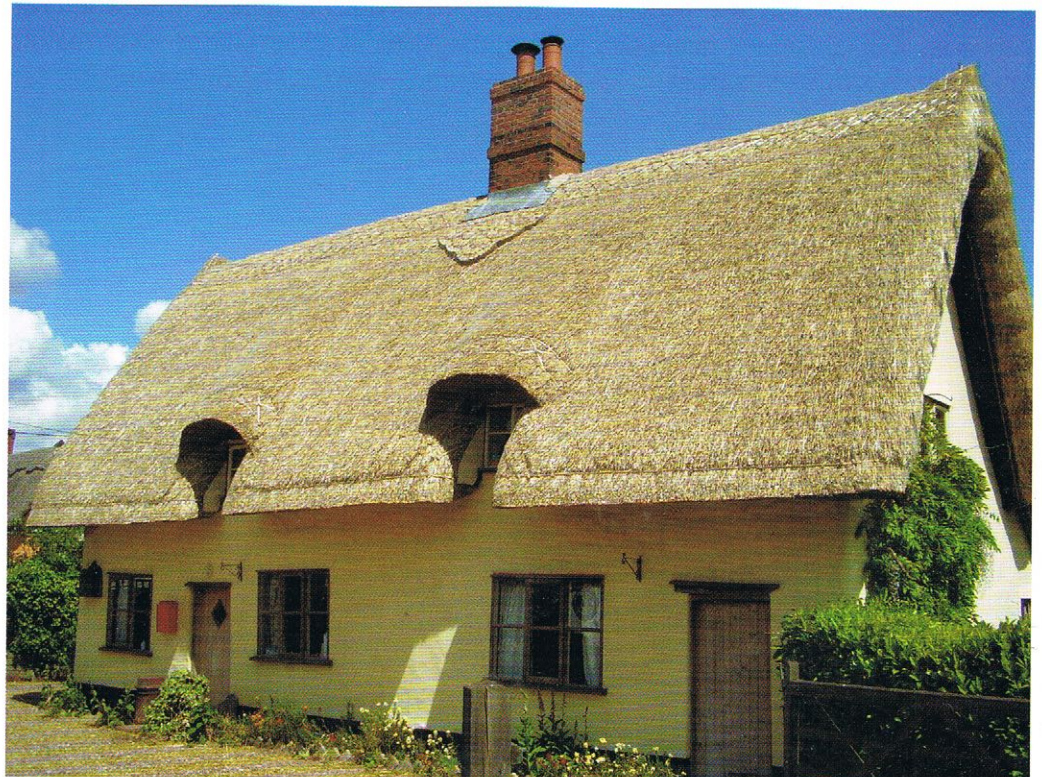
*Figure 9.*  
Typical authentic  
Norfolk long-straw  
thatch (in Pulham St  
Mary) with a flush  
ridge finish, as seen  
commonly before the  
mid-20th century.

The use of thatch on dwellings declined dramatically from the start of the nineteenth century onwards, due to the factors outlined above. The perceived requirement for netting made straw thatch the most expensive type of roof, with confidence in it lost accordingly. Matters were compounded by the development of an anti-thatch lobby, through which the vested commercial interests of roofing material manufacturers and their well-positioned (and paid) commentators argued hard against retaining thatch (Letts & Moir). As a result, our rural built heritage changed dramatically in character within a few short decades. The legacy of a thatching heritage in the Brecks remains visible today in the form of steep pantile-roofed old properties with taller than usual chimneystacks: a tell-tale sign that those roofs were thatched previously with long-straw thatch.
